Fruit Farm Creek Restoration Project

MONITORING REPORT 2020

Prepared for
Ivan Bowen Family Foundation

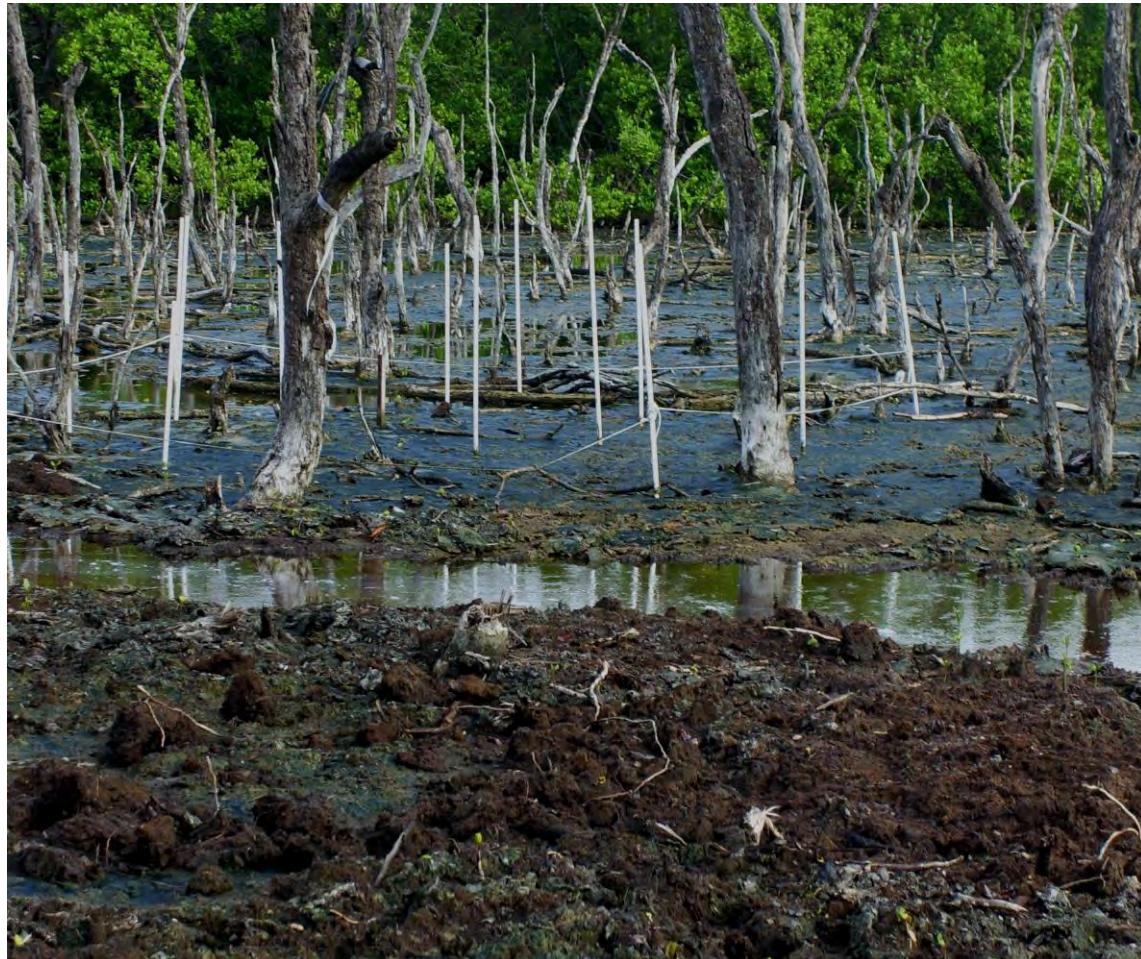
Appendix 1: Restoration in Progress 2015

One of the Completed Hand-dug Channels placed within the Die-off Area to Establish a Tidal Connection to Fruit Farm Creek River that leads into the Gulf of Mexico. These hand-dug channels allow impounded freshwater to drain and allows for tidal flushing to occur within the die-off.
